Volume 14 Number 16 March 2025

What would cause this? Unexpected fertilizer injector problems

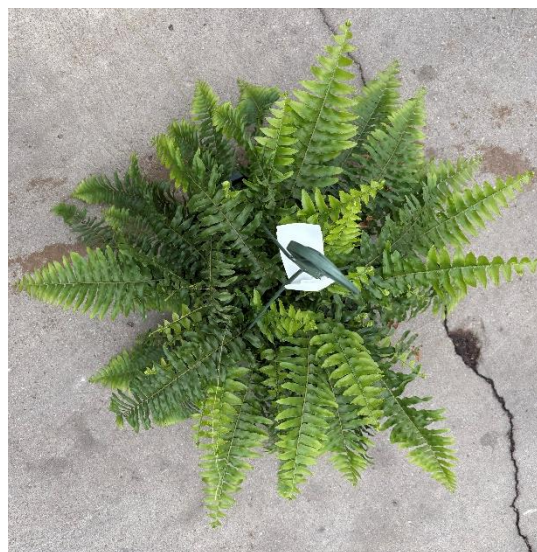
Figure 1. This Boston fern (*Nephrolepis exaltata* ‘Bostoniensis’) appeared chlorotic. After the greenhouse environment and chemical applications were ruled out, mineral nutrition and fertilizer seemed to likely be the root cause of the issue.

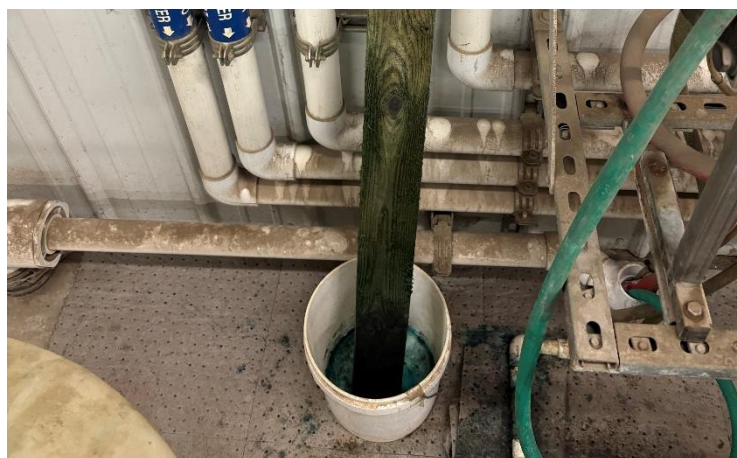
The injector itself seemed ok, but after looking at different parts, the grower found a piece of wood that was blocking sufficient uptake of fertilizer stock solution. Where in the world did this piece of wood come from? Although it seems unlikely to find wood in an injector, the grower realized the “mixing stick” they use when mixing stock solutions (Figs. 2 and 3). Once the wood was removed, the EC of the fertilizer solution was spot-on, and with the Boston ferns started receiving the correct amount of feed, the grower had time to look for a new stick (Fig. 4)!

Figure 2. This is the “mixing stick” used to blend fertilizer stock solutions. Seemingly innocuous enough, it turned out to be the cause of the injector malfunction.

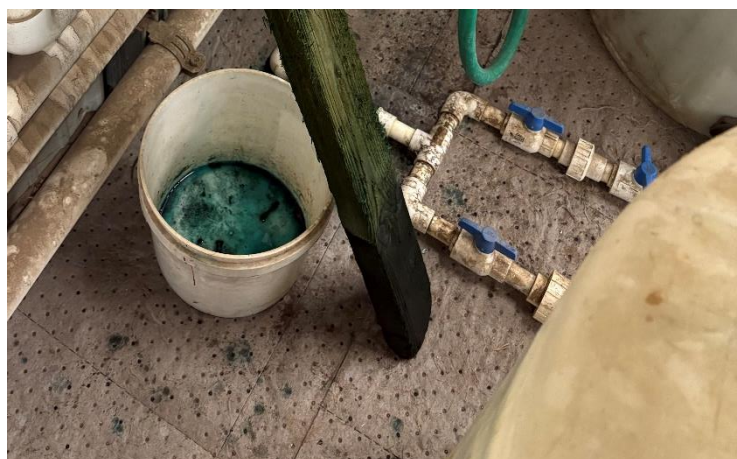
Figure 3. Upon closer inspection, the “mixing stick” is showing some wear and tear. You can see pieces of wood splintering off from the stick, and this turned out to be the source of wood that clogged the injector.

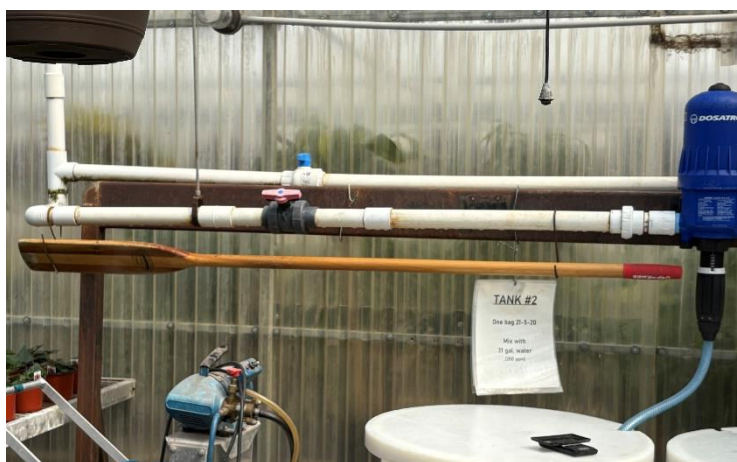
Figure 4. Here is a different grower with a very similar set up. While the injector is different, it has the same two-stock tank set-up, along with a mixing stick. Note that this “mixing stick” is showing much less wear and tear, reducing the chances it will inhibit proper functioning of injectors.
